Recovery of degraded and transformed ecosystems in coal mining-affected areas

Deliverable 3.3

Assessment of rehabilitation techniques for waste heaps

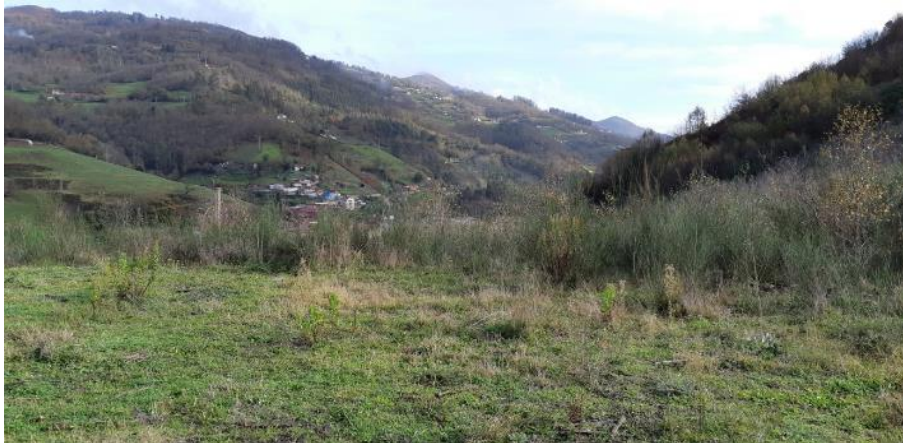
Figure 6. Berm in Sector 1

Figure 6 presents a berm in Sector 1, and Figure 8 and Figure 8 present two details of the vegetation in the berm. Figure 9 presents a view of Sector 1 from the pit area at the bottom of the dump.

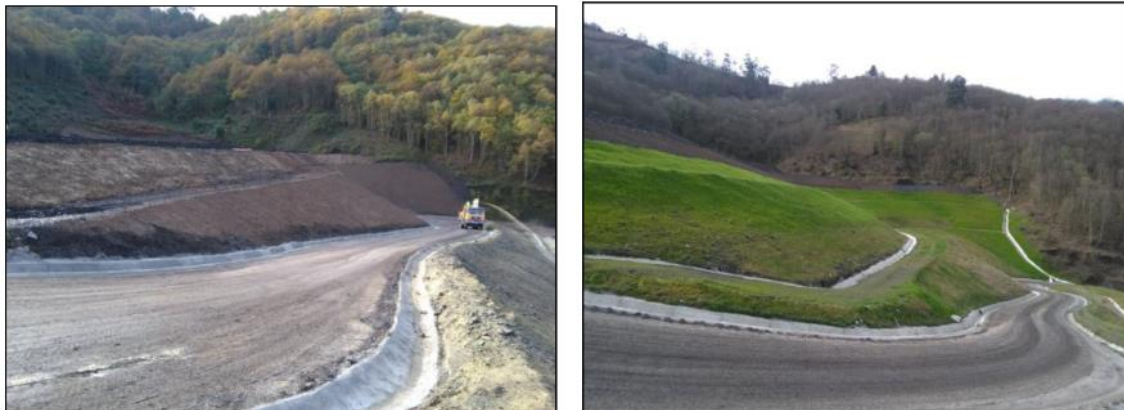
Figure 17. Sector 3 in November 2016 and in April 2018

Hydroseeding of Sector 3 took place in November 2016, October 2017 and April 2018, using the same components and seeds than in Sector 2. Figure 17 presents the previous stage in November 2016, and the results achieved in April 2018.

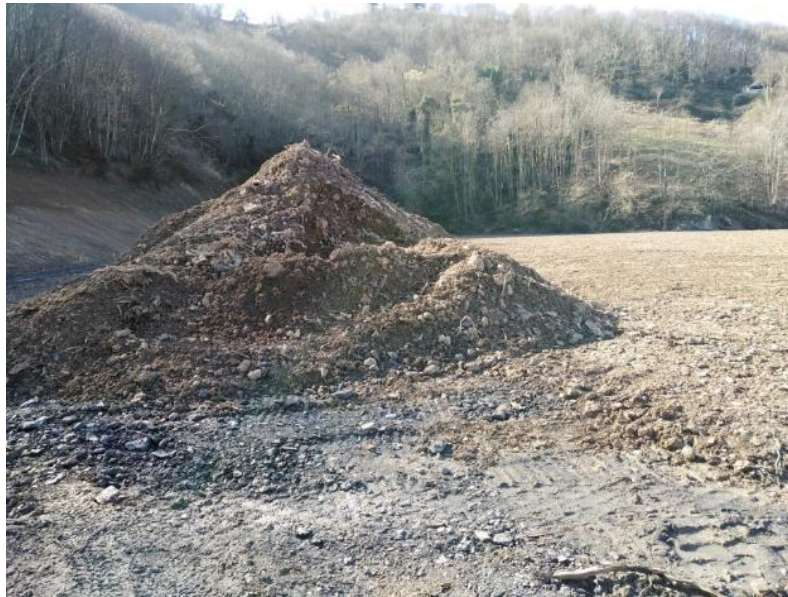
Figure 19. Top of Sector 3 in February 2020

The top part of Sector 3 was hydroseeded on February-March 2020 (Figure 19), and after nine months the state of development is presented in Figure 20.

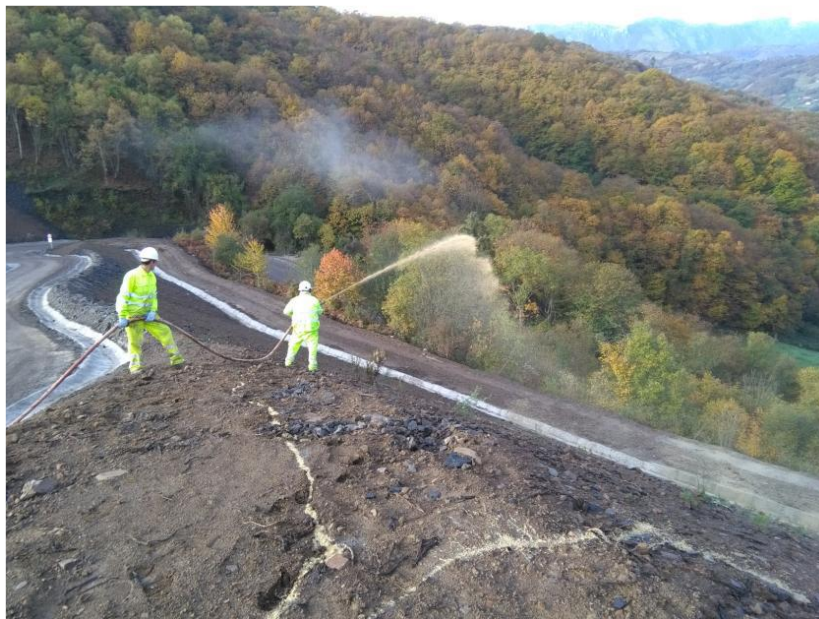
Figure 21. Hydroseeding projection

Finally, Figure 21 presents the hydroseeding projection in Sector 3.

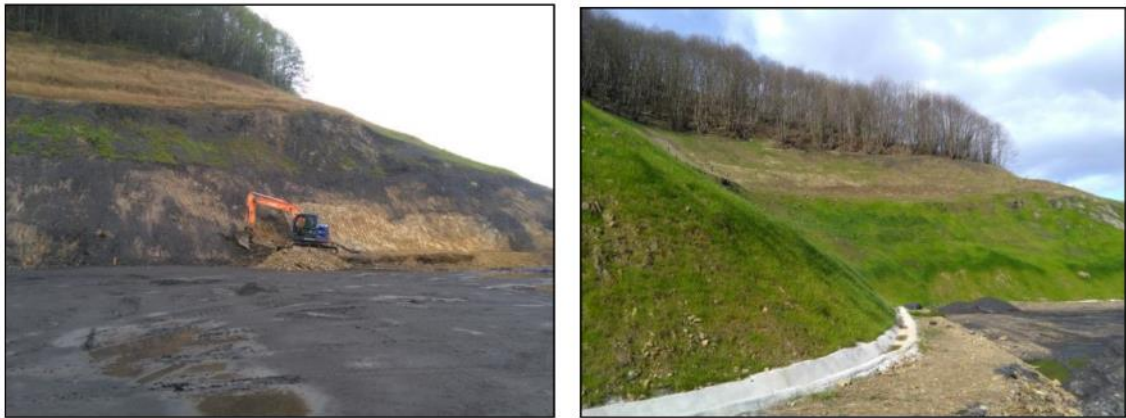
Figure 27. Sector 4 in October 2016 and in April 2018

The proceedings and methods used in the restoration of Sector 4 were the same than in the other sectors, except the use of coconut mesh in the areas with a steep slope (Figure 27).

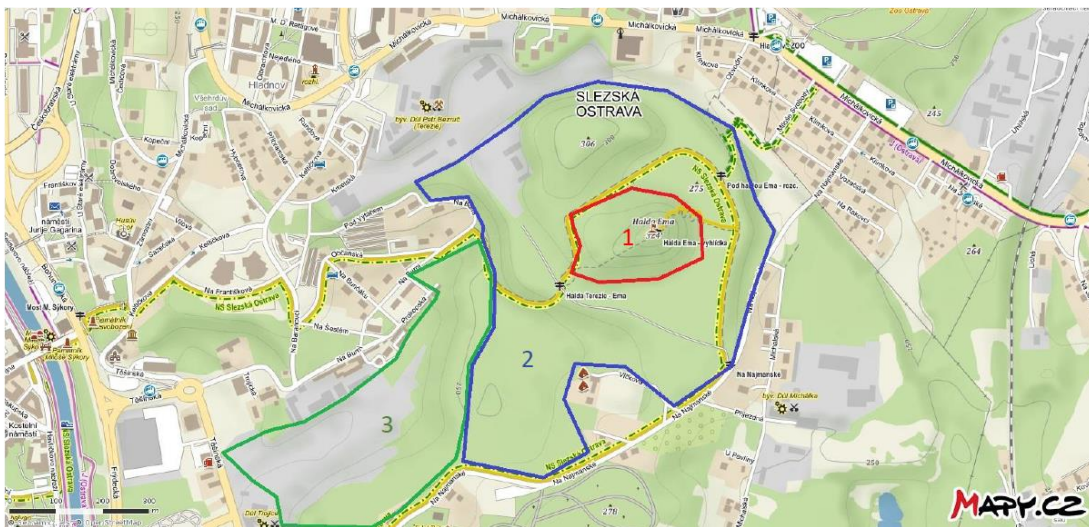
Figure 28. Mine spoil dump Ema – Terezie complex - segments of reclamation

The area of the dump Ema - Terezie complex is divided into three segments in terms of the use of reclamation techniques (see Fig. 28):

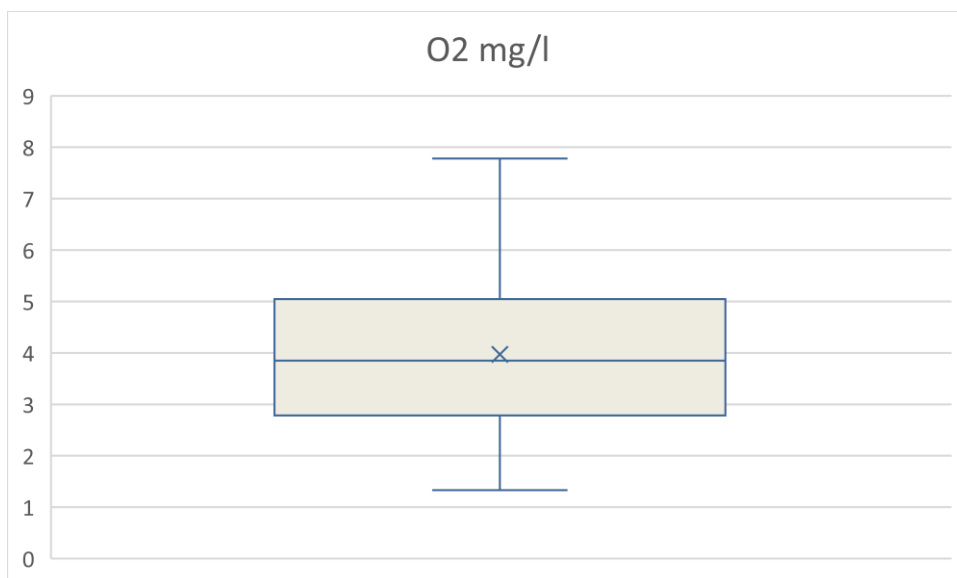
Figure 41 Box plot of Oxygen

Limit p, according the Czech legislation, is more than 9 mg/l

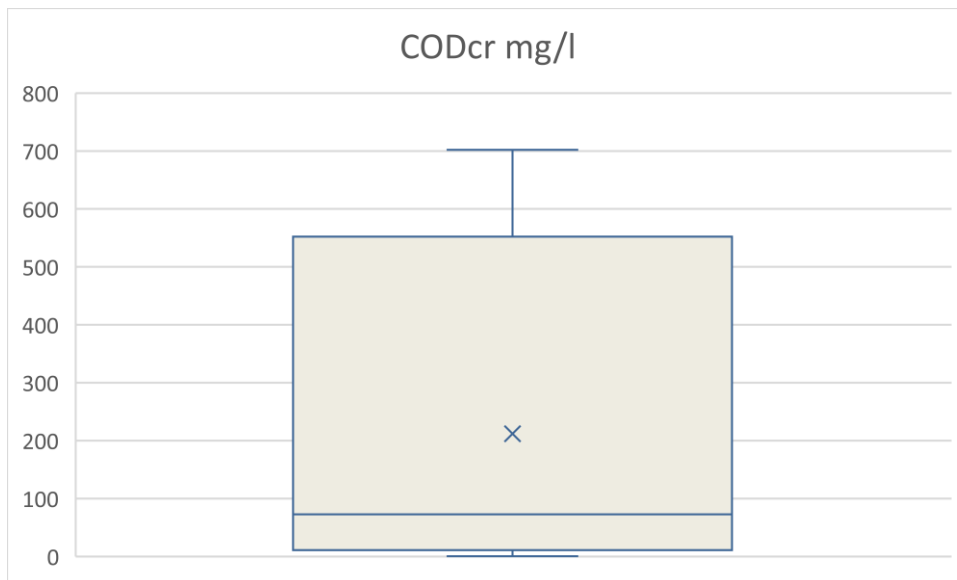
Figure 42 Box plot of CODCr

Limit p, according the Czech legislation, is 26 mg/l

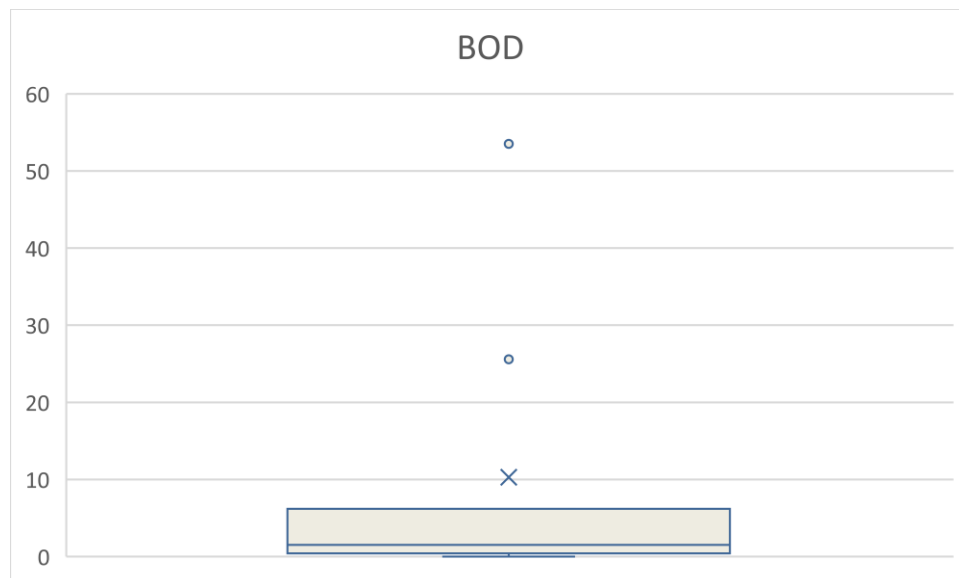
Figure 43 Blot box of BOD

Limit p, according the Czech legislation, is 3,81 mg/l

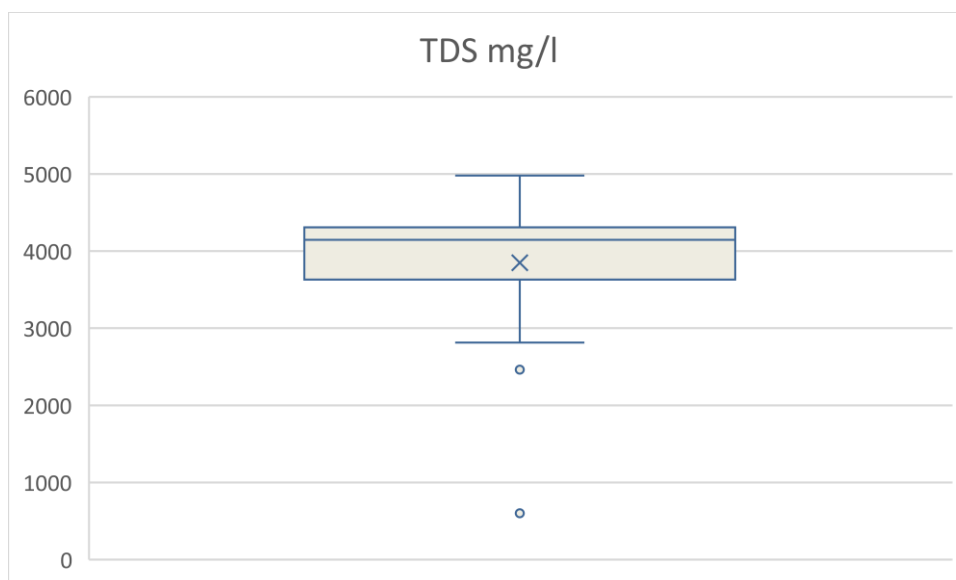
Figure 45 Box plot of TDS

Limit p, according the Czech legislation, is 750 mg/l

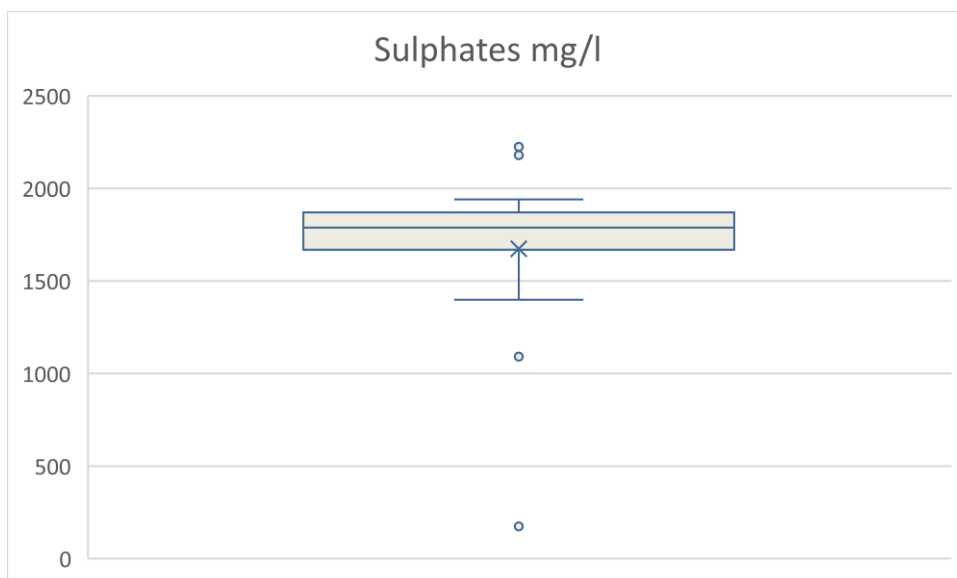
Figure 49 Box plot of Sulphates

Limit p, according the Czech legislation, is 200 mg/l

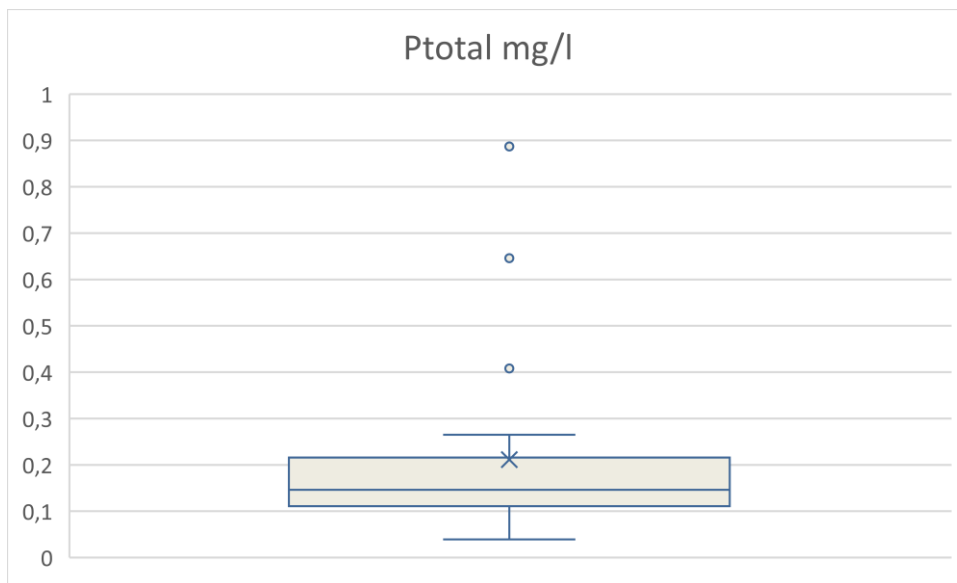
Figure 50 Box plot of Ptotal

Limit p, according the Czech legislation, is 0,15 mg/l

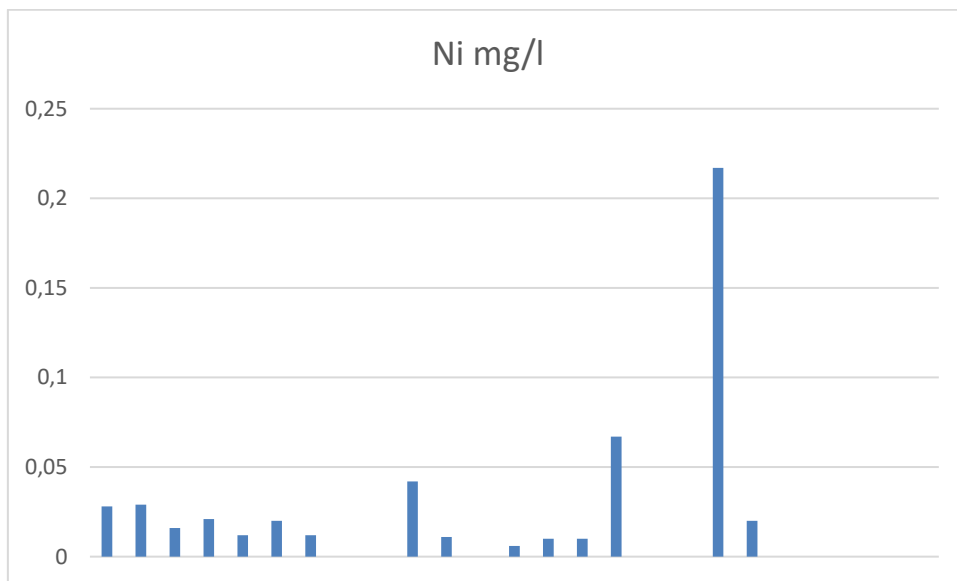
Figure 54 Value of measurement Ni

Limit p, according the Czech legislation, is 20 µg/l..... 0,020 mg/l

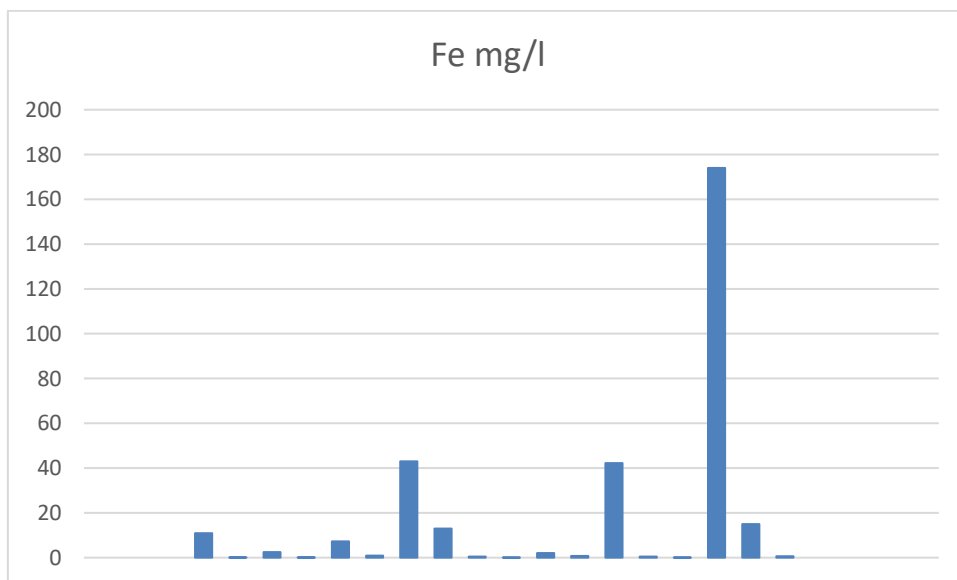
Figure 55 Value of measurement of Fe

Limit p, according the Czech legislation, is 1 mg/l
